The Destructive Extent  
of the California Earth-  
quake. Its Effect Upon  
Structures and Structural  
Materials Within the  
Earthquake Belt.

By Charles Derleth, Jr.

Associate Professor of Structural  
Engineering, University of California

1907

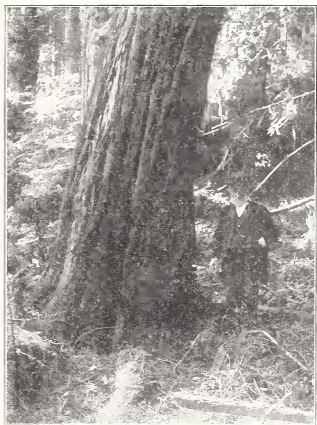
FIG. 3.—Redwood Tree, Situated on the Fault Line, near Fort Ross.  
Sonoma County, California.

sides of the fault, which explains the cracking at the base of its trunk. Many trees were more or less ruptured along the fault where the line traverses timber growths; and in one place I observed leaning redwood trees for a con-

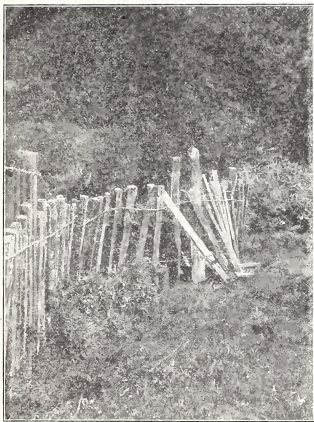
FIG. 5.—Fence near Fort Ross, Sonoma County, California, Offset  
Nine Feet at the Line of Fault.

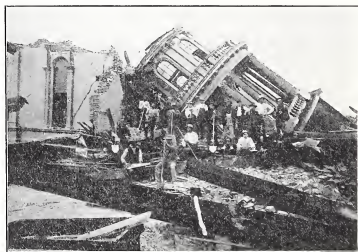
FIG. 10—*The Collapsed Court-House Dome, Santa Rosa. The View Is Taken with the Camera on the Second-Story Roof; See Fig. 9. The Court-House Consisted of Three Stories of Brick, the Third Story Smaller in Plan Than the Other Two. The Third Story Supported the Wooden Dome.*

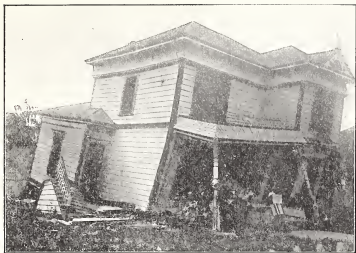
FIG. 15—Frame House Wrecked in Santa Rosa; Due to Weak and Decayed Underpinning.

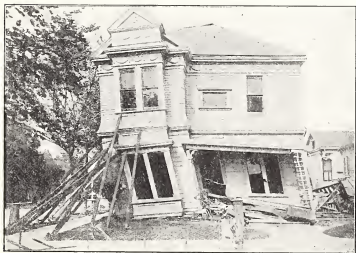
FIG. 16—Collapsed Frame House in San José Showing the Effect of a Lack of Transverse Framing and an Absence of Continuity in the Vertical Sticks at the Floor Levels.

shock and represent a most desirable type for small dwellings. The weak feature is the brick chimney. But even this can be built so that cracking will not be so complete as to cause fire. For earthquake countries wooden buildings should be intelligently framed to act like an elastic cage or unit, and the foundations should be carried below the surface sufficiently to reach firm ground. It is too common a practice which completes one story of a framed house before starting the frame for the next story. Where there is no continuity in the main wall framing from floor to floor, weakness exists at the floor level; consult Fig. 16.

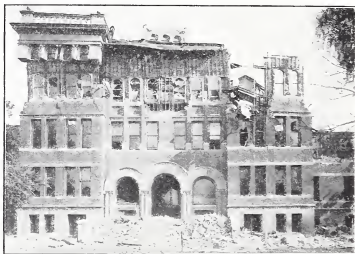
FIG. 17—*A San José High School. Ordinary Brick Construction with Wooden Interior.*

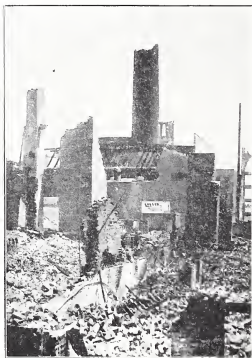
FIG. 20—Fire Ruins of a Power-House of the San Francisco Gas and Electric Company, Station C. The Chimney of This Structure Fell During the Earthquake Shock, Demolished a Part of the Equipment and Killed One Person.

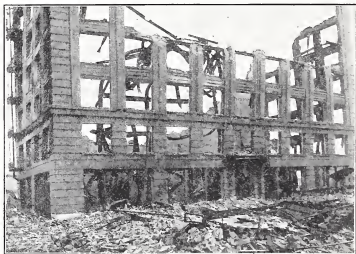
FIG. 22—Fire Ruins of the Cowell Building, a Class B Structure, Showing the Great Destruction by Fire.

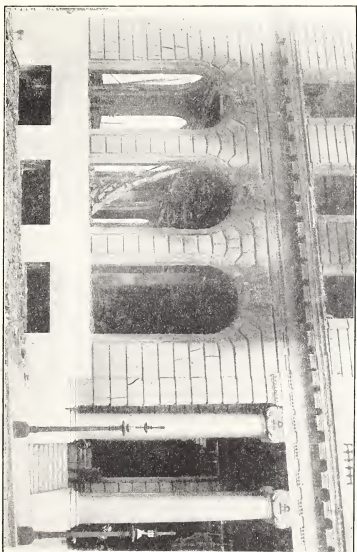
FIG. 28—St. Francis Hotel, Southeast Corner, Showing Heavy Earthquake Cracks in the First Story of the Southstone Front.

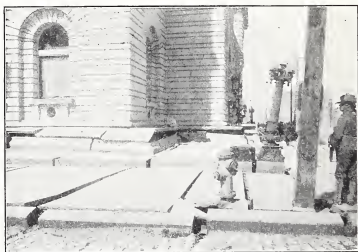
Important structures should not be built on treacherous ground. The site of the general Post-office (Fig. 27) was very unhappily chosen. That

FIG. 27.—General Postoffice, Southwest Corner, Showing Severe Distortion and Subsidence of the Sidewalk and Street Levels.

building, while exceedingly well built, rests on filled ground, and under its southwest end ran an arm of the Mission Creek. In this vicinity the ground was very much disturbed, and the street fell away from the building. The structure, while it stood and was saved from fire, was severely racked, and its beautiful granite fronts were badly

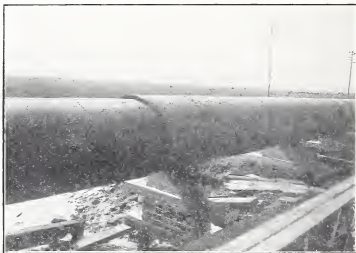
shook like a bowl of jelly, the vibration being mainly in a south-southeasterly direction or nearly at right angles to the length of the trestle. It appears that during the vibrations of the earthquake

FIG. 31—Rupture of the 44-inch Crystal Springs Conduit on the San Bruno Marsh; Picture Taken May 2, 1906. The Wooden Supports under the Pipe Are Temporary Forms Built after the Catastrophe. The Pipe Has Been Straightened Preparatory to Repairing the Transverse Riveted Joints.

the trestle moved with mother earth. The pipe, due to its inertia, tended to remain quiet. As a result the pipe was alternately thrown from one side to the other of the trestle floor and its wooden box covering was generally smashed. The pipe broke at transverse circular riveted joints, sometimes by tension, and sometimes by crushing. Fig. 31

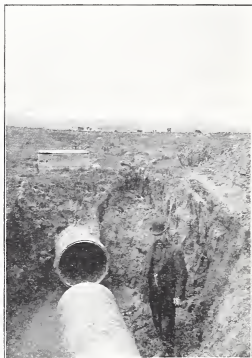
FIG. 34—Rupture on Pilarcitos Pipe Line near North End of San Andreas Reservoir.

compensating places the pipe was telescoped by similar amounts. Fig. 34 shows a break in this pipe line near the up-stream end of San Andreas Lake. The pipe at this point was pulled apart  $53\frac{1}{2}$  inches. A property fence, Fig. 6, which crossed

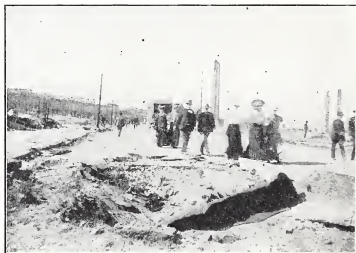
FIG. 40—Gas Main Explosion, Valencia Street, near Market Street, San Francisco.

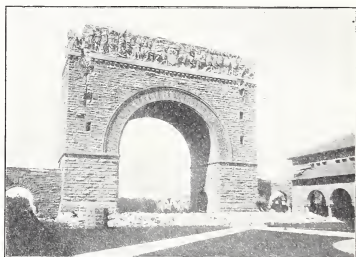
FIG. 42—Rear View Memorial Arch, Stanford University, Showing Arch Ring Intact.

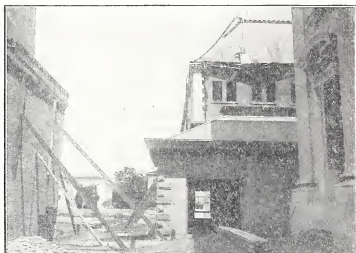
FIG. 48—Rear View, Hall of Records, San José, Showing How the Heavy Stone Outer Walls Cracked Away from the Interior Framing Due to Improper Anchoring of Walls to Floors and Roof.
